REDUCTION OF DEFECTIVE PRODUCTS IN THE PRODUCTION OF VIBRATION DAMPER

Krzysztof MICHALSKI^{1*}, Artur GALIK²

Keywords: vibration damper, defect in the production.

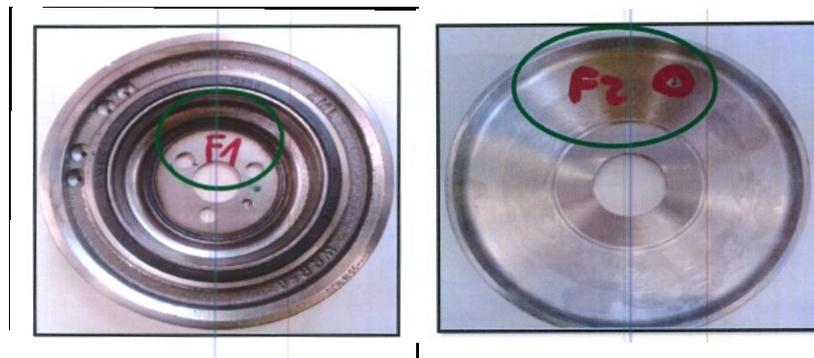
In order to identify non-conforming products, a list of the most frequent defects along with codes assigned to them was developed, e.g. offset (F1), cast defect – pit (F2), cut teeth (F5), incorrect diameter (F7), incorrect position of holes (G1), imbalance (G2), radial run-out (G5), mechanical surface damage (G7), axial run-out (H7), badly pressed rubber (I1), corrosion on surface of the part (J4), pressing force out of tolerance (J5). Examples of defective components are shown in Figure 3.

Figure 3. Examples of defects occurring in the production of the vibration damper, described with the codes a) F1 – offset, b) F2 – cast defect.

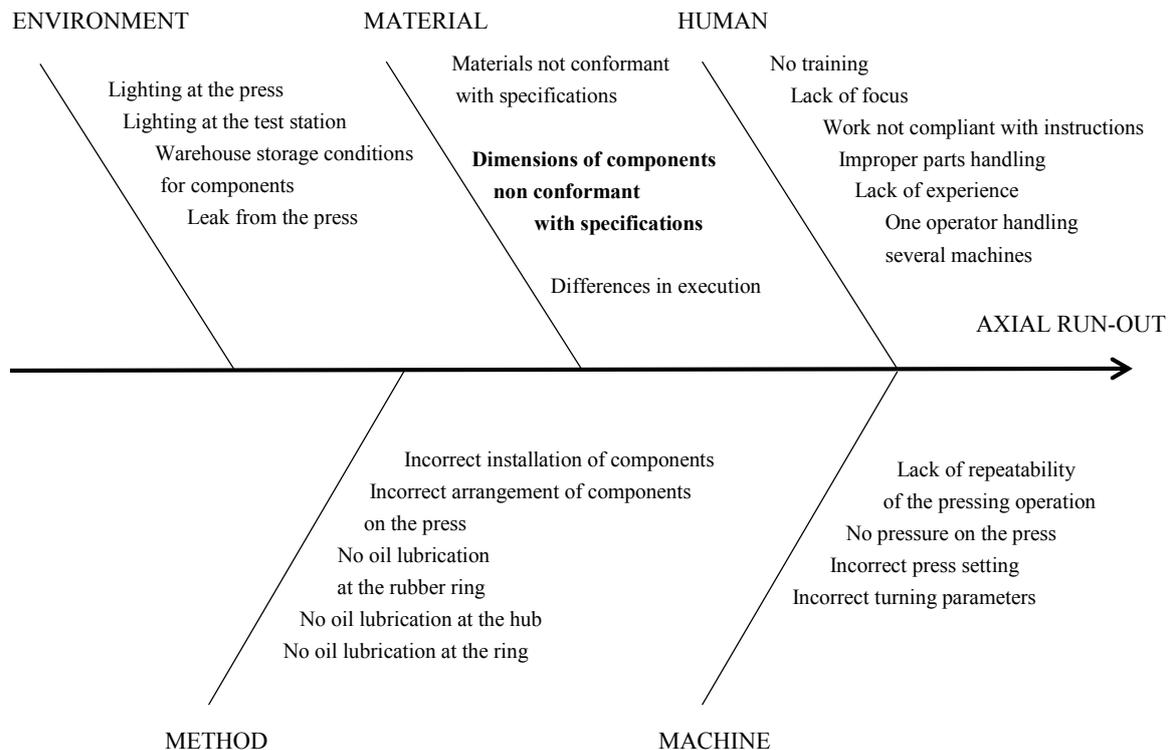
Figure 9. Ishikawa diagram for axial run-out.

1. Environment: lighting at the press, lighting at the test station, warehouse storage conditions for components, leaks from the press.
2. Materials (hub, outer ring, rubber ring) are not conformant with specifications (diameter), outer ring not conformant with specifications, rubber ring not conformant with specifications, differences in execution.
3. Human: no training, no focus on operations performed, work not compliant with instructions, improper parts handling, lack of operator's experience, one operator handling several machines.
4. Method: no oil lubrication at the hub, no oil lubrication at the ring, no oil lubrication at the rubber ring, incorrect arrangement of components on the press.
5. Machine: no pressure on the press, incorrect press setting, lack of repeatability of the pressing operation, non-conformant tooling geometry, incorrect turning parameters.

The cause of the non-compliant product was the dimensions of components (hub) being non-conformant with specifications. The hub diameter was out of specification due to improper clamping of the cutting tool. Cutting tool attachment control is a solution that was immediately implemented.
