## ARCHITECTURAL RESEARCH IN THE PROCESS OF IDENTIFYING THE RESTRUCTURING OF BUILDINGS USING THE TOWN HOUSE AT 1 RYCERSKA STREET IN BYTOM AS AN EXAMPLE

**Purpose:** Identification of the successive stages of construction, restructuring and disassembling of the former hotel buildings at 1 Rycerska Street in Bytom.

**Design/methodology/approach:** The following architectural research was undertaken: analysis of archival documentation and the current state of preservation of the building; collection and testing of mortar and wood samples; an inventory (laser scanning) and comparative studies of the stone cellars and eastern wall, the southern and western walls (including lintels on the third floor) and an external wall, the remains of the former connecting wall between the existing building on Rycerska Street and the demolished one at Grunwaldzki Square; also studies comparing the building's cellars on Rycerska Street with other previously known structures in Bytom such as the cellars of the western frontage of Rynek (Market Square).

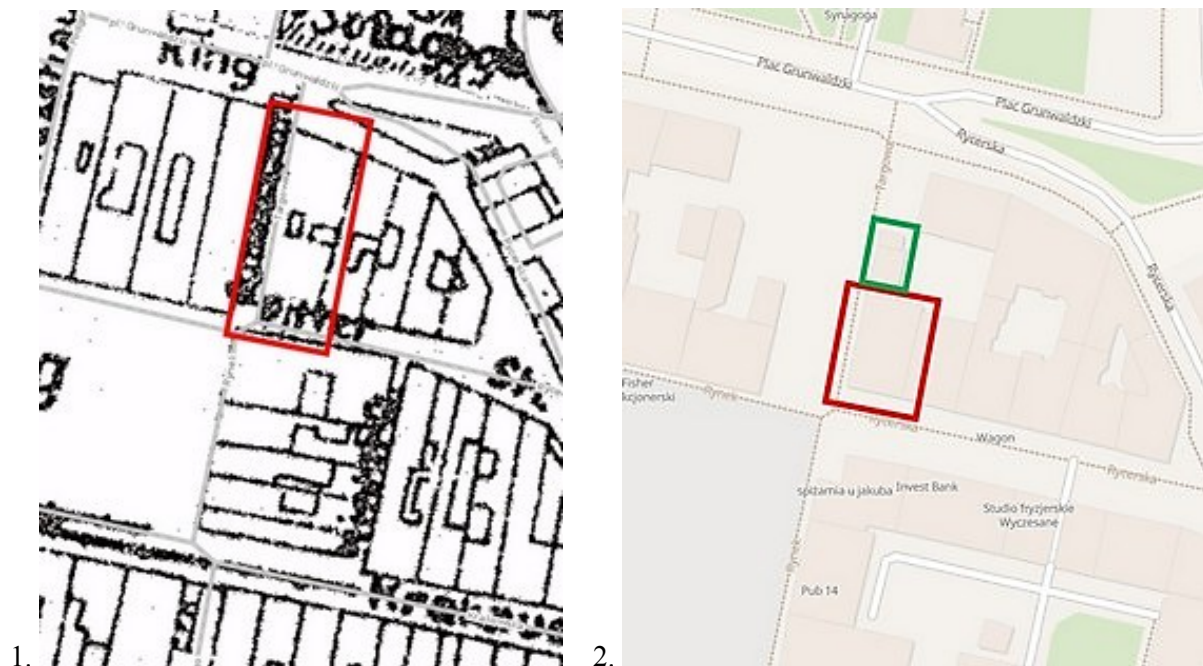
**Figure 1, 2.** Part of a historical map from 1926 showing the plot location of the town house at 1 Rycerska Street in Bytom; also part of a map of the building prior to reconstruction and extension in 2021.
