ELIMINATION OF INCONSISTENCIES IN THE PROCESS OF EXPANDING THE FLEET OF ELECTRIC BUSES

Purpose: The aim of the work is to present selected research results of the first stage of work, the so-called pre-design research related to the implementation of electric vehicles into the company's fleet.

Category of the paper: Case study.

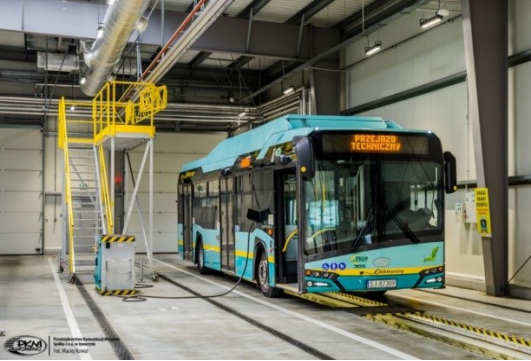
Figure 2. Service hall with a platform to work on the roof of an electric bus with many components

<p>Vehicle servicing and maintenance problem The company lacks employees who can work at height and regularly service structural components on the roof of vehicles. Not enough equipment to reach the roof of the vehicle Conclusion: Service employees should be referred immediately to the appropriate courses and obtain additional authorisations to work at height, it is imperative to comply with health and safety regulations</p>

Activities introduced to the company
Problem with appropriate response to alerts – low battery	For the project related to the deployment of a fleet of 20 vehicles to the plant, the employment of at least one person to supervise the vehicles and an additional person to operate the vehicle fleet was included. Estimated cost of implementing the solution: - full-time employee of the dispatching centre - 4000 PLN gross per month, <ul style="list-style-type: none"> • training - 4200 PLN.
Problems with vehicle servicing and maintenance	For the project related to the implementation of a fleet of 20 vehicles, additional equipment was purchased, i.e. platforms, ladders and even overhead cranes. Estimated cost of implementing the solution: - platform - PLN 17,000, - ladder - 5000 PLN, - crane - 30000 PLN. As the existing employees of the service had acquired the necessary qualifications by the time the work at this stage of the project commenced, all new service employees should be directed to appropriate courses and acquire additional qualifications for work at height.
